# Manhole Inspection Summary

Manhole # S25A\_\_008MH

**Location** Address: **718 ARLINGTON-CARROLLTON**

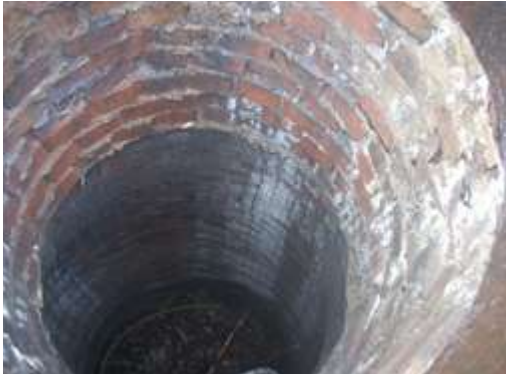
Defect 2

Infiltration: ☐ None ☒ **Joint** ☐ Cracks ☐ Mortar ☐ Roots ☐ Wall

BARREL INFILTRATION

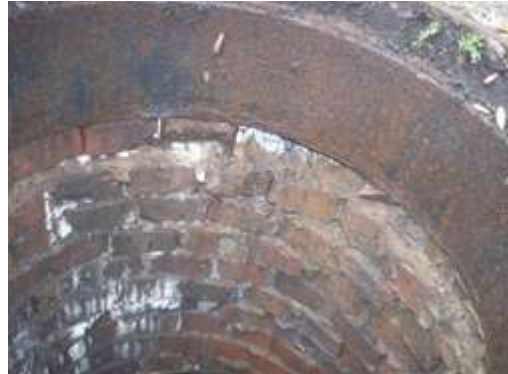
Defect 1

Condition: ☐ Sound ☐ Cracked ☐ Root Intrusion ☐ Loose Brick ☒ **Deteriorated**

Infiltration: ☐ None ☐ Joint ☐ Cracks ☐ Mortar ☐ Roots ☒ **Wall**

INFILTRATION AND DETERIORATION  
OF CHIMNEY

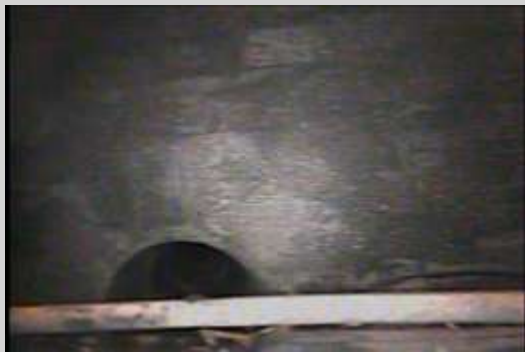
12 O'Clock Outflow

Deposits: ☐ None ☐ Mud ☐ Sludge ☒ **Debris** ☐ Grease

Silt Depth: **5** (in.) Deposits Extent: **Medium**
